Avery Landing 008.JPG
09/15/2000
View of backside of coffer dam
Petroleum film evident

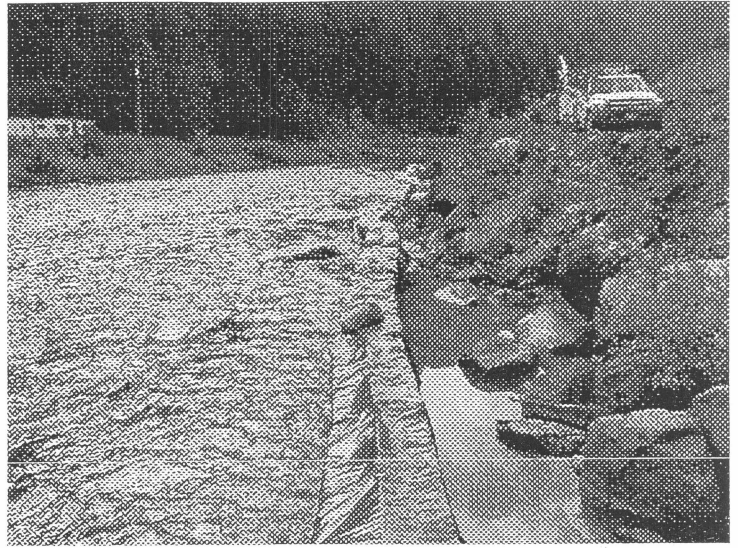
Avery Landing 009.JPG
09/15/2000
Viewing downstream at coffer dam

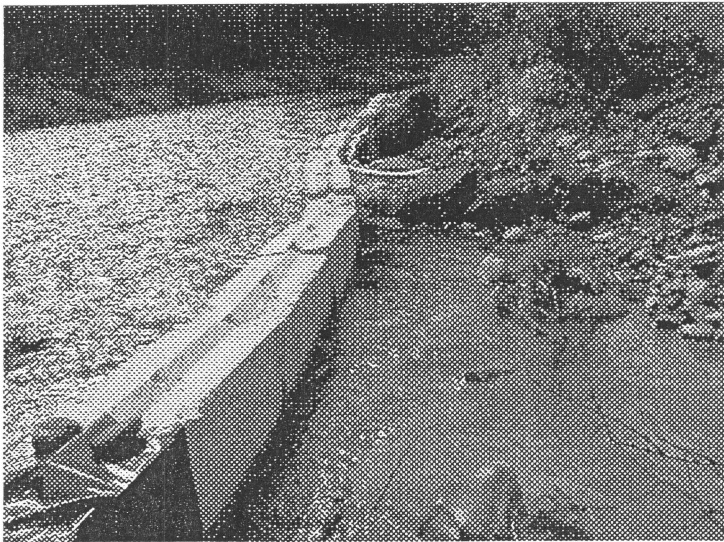
Avery Landing 010.JPG
09/15/2000
Viewing downstream at coffer dam

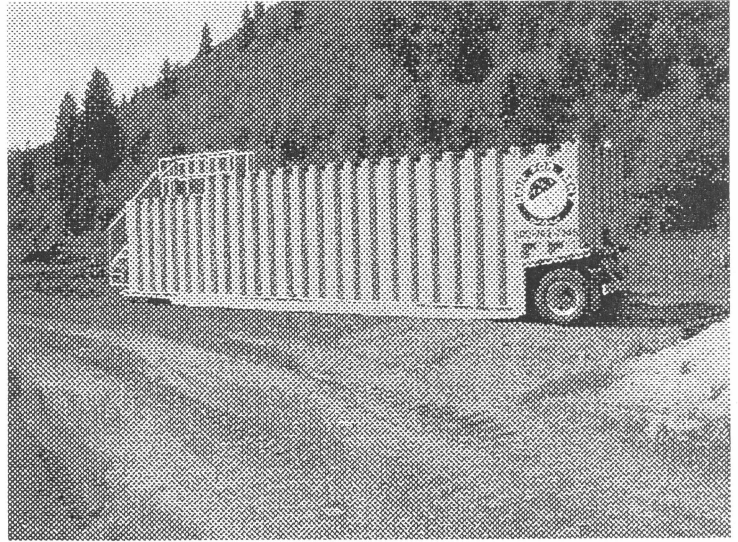
Avery Landing 011.JPG
09/15/2000
Oil/water separator being used on site

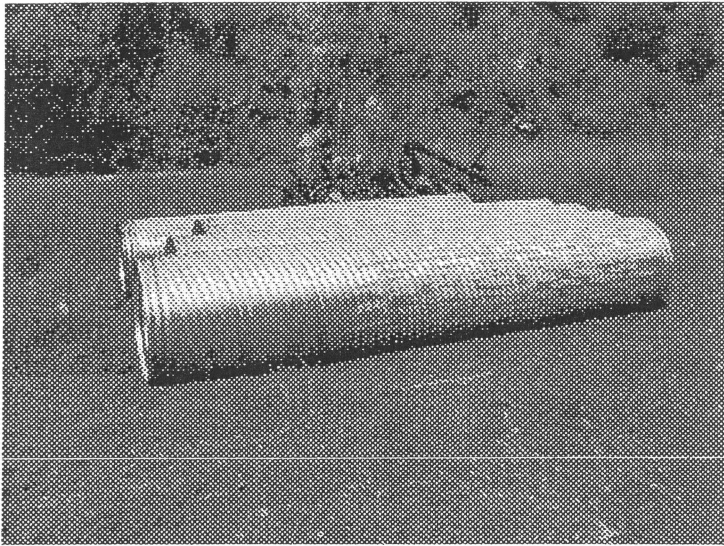
Avery Landing 012.JPG
09/15/2000

Photo of recovery wells that will be placed just upgradient of liner

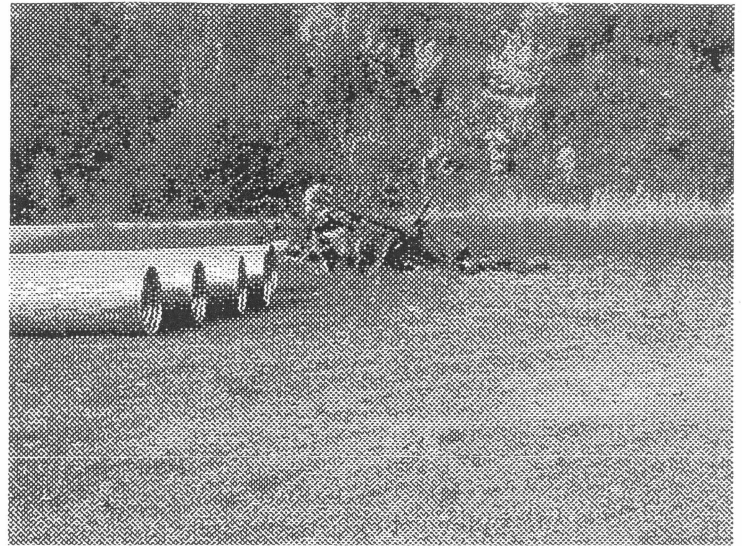
Avery Landing 013.JPG
09/15/2000

Photo of 3' diameter recover pipes

*& junk metal that has been excavated
from stream bank*

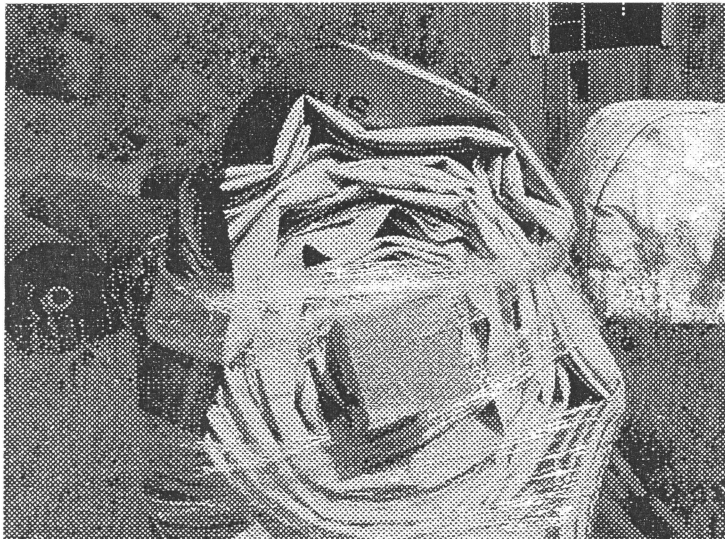
Avery Landing 014.JPG
09/15/2000

Photo of liner that will be placed along stream bank

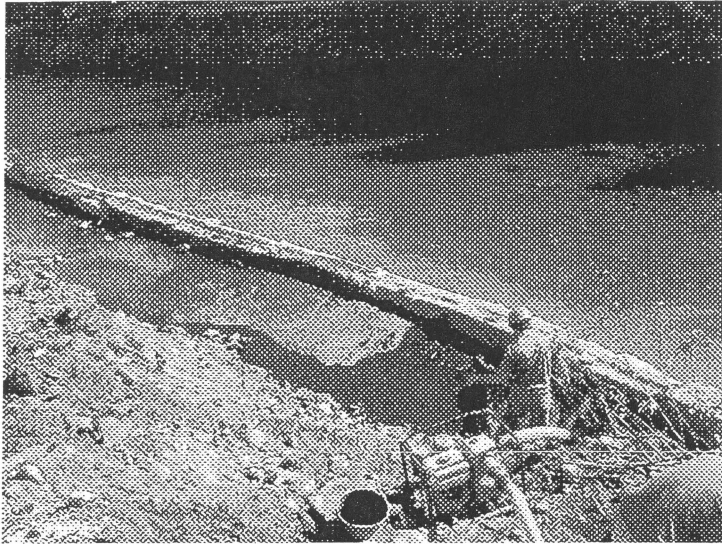
Avery 008.JPG
09/25/2000

Viewing upriver from W end of site. Lots of petroleum behind coffer dam;
some silting outside of dam

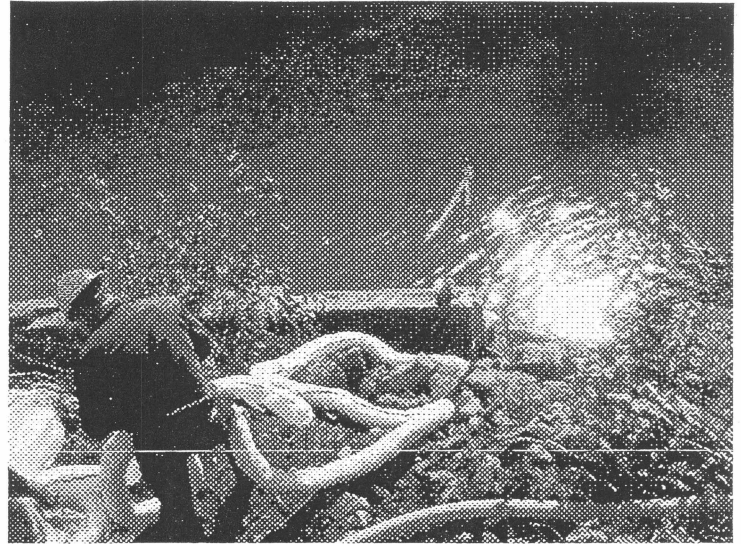
Avery 009.JPG
09/25/2000

Potlatch workers adding new boom to W end of site where minor amounts of
petroleum were escaping thru coffer dam

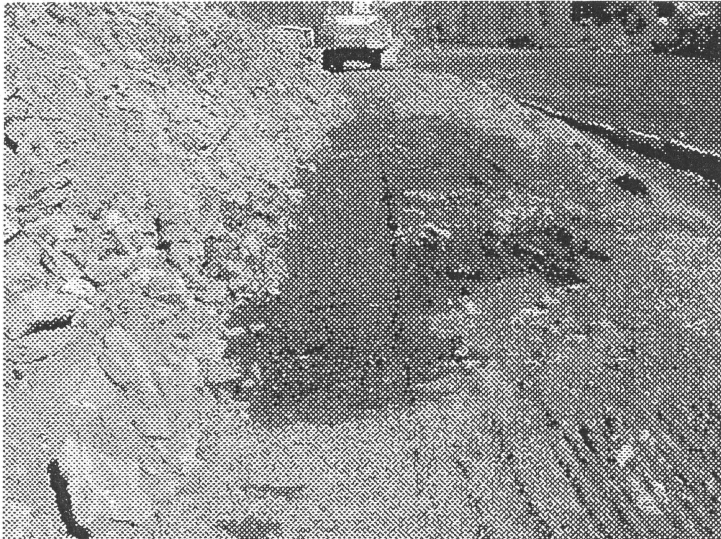
Avery 010.JPG
09/25/2000

Petroleum seep on bench in approx. center of site. Unknown whether this
came from heavy equip or ground

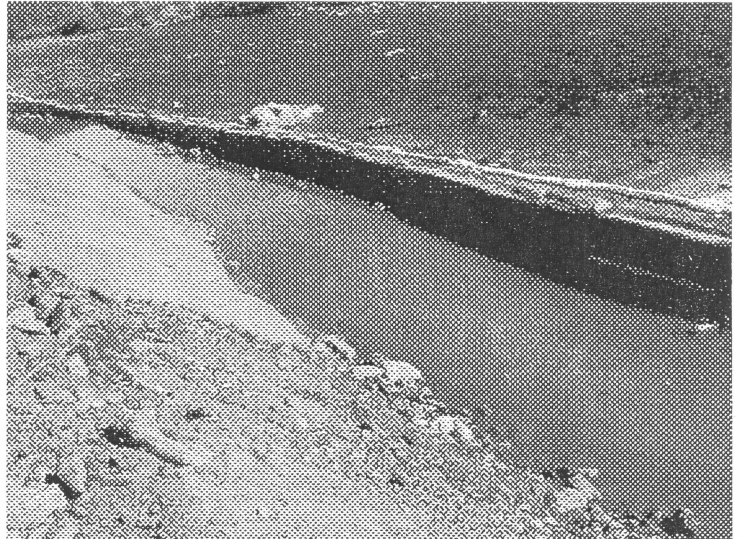
Avery 011.JPG
09/25/2000

Photo of silt and oil behind coffer dam on W end of site

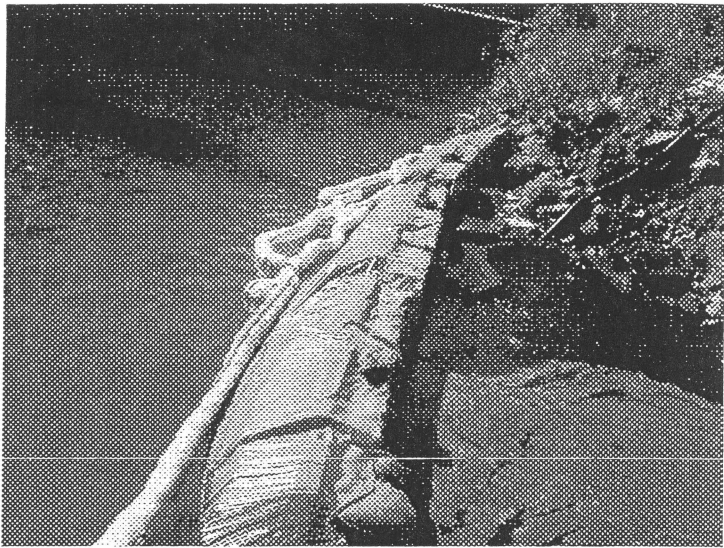
Avery 012.JPG
09/25/2000

Viewing downstream @ contaminated W end of site, behind coffer dam

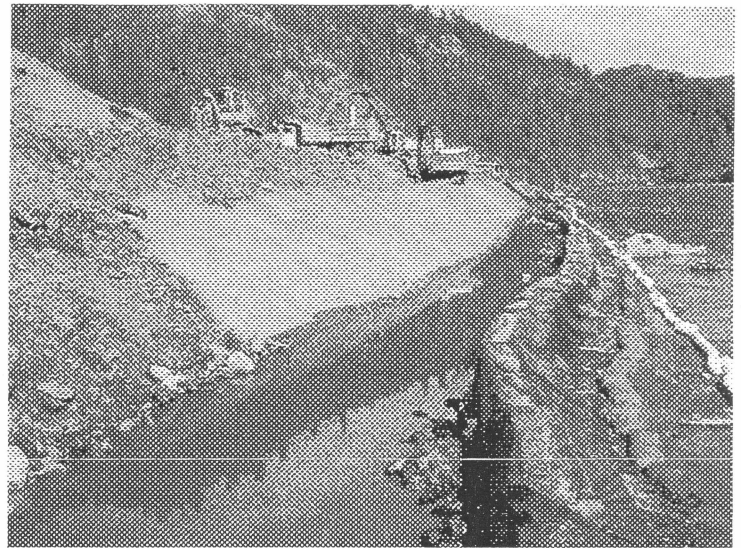
Avery 013.JPG
09/25/2000

Viewing upstream across entire coffer dam

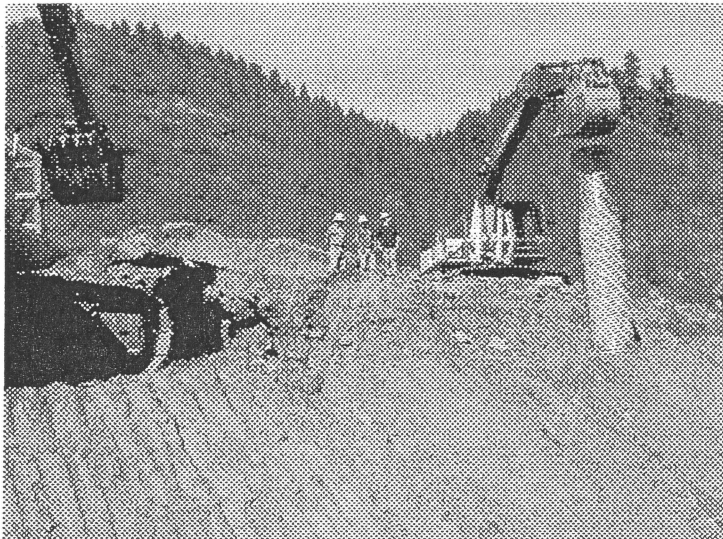
Avery 014.JPG
09/25/2000

Photo of one of the extraction wells being installed

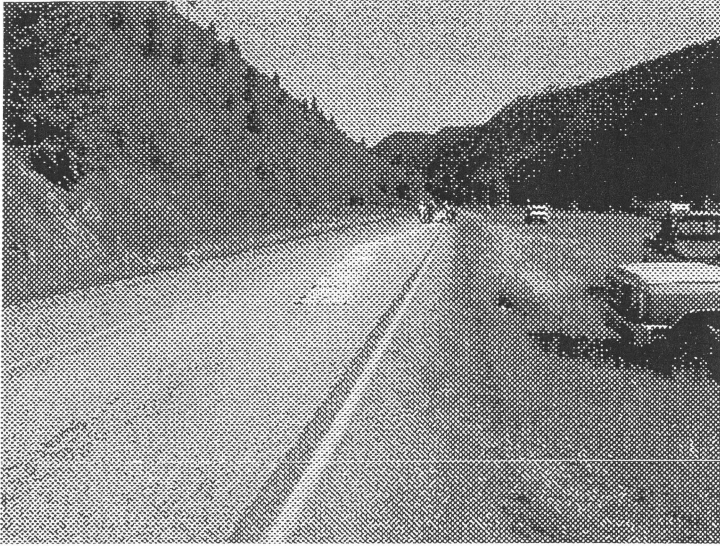
Avery Landing CAP 008.JPG
09/27/2000

Liner being rolled out on hwy to be unfolded and rolled back up on a long steel bar

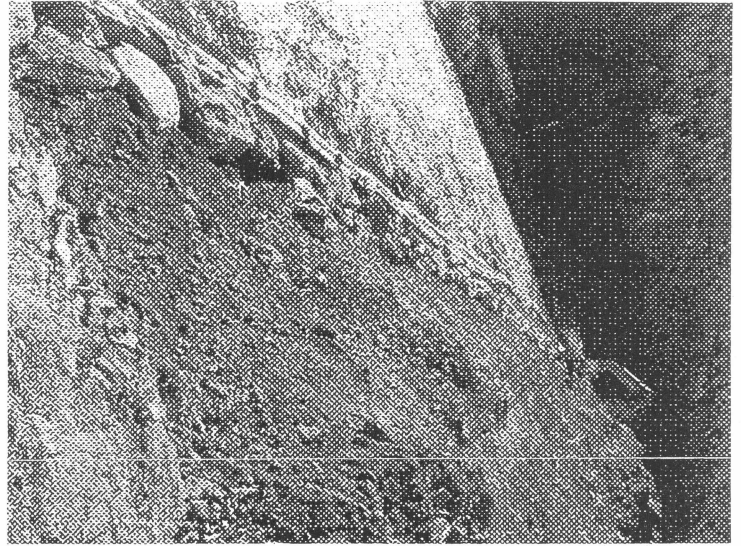
Avery Landing CAP 009.JPG
09/27/2000

Viewing downriver from E end of site. Liner and rip rap have already been installed in this area

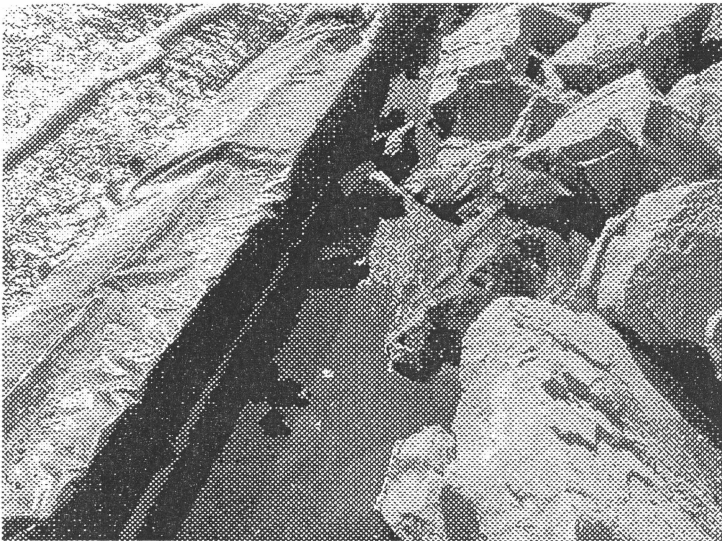
Avery Landing CAP 010.JPG
09/27/2000

Small area of petroleum scum forming behind coffer dam, about 1/3 of the way downstream from E end of site

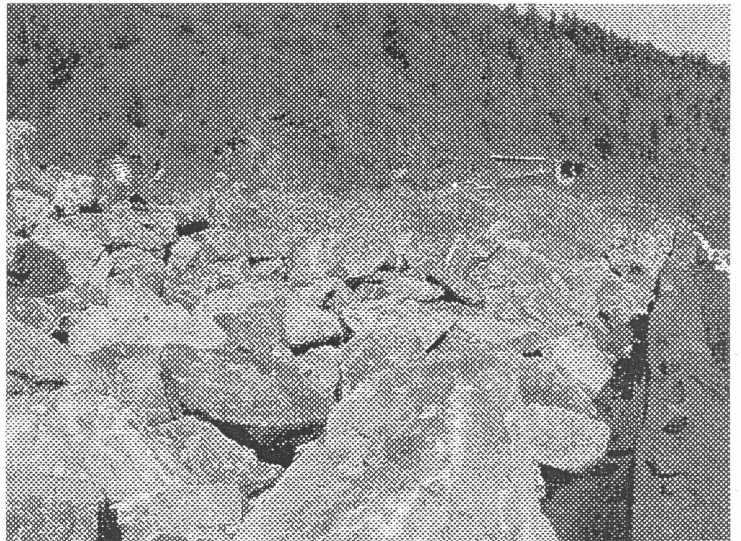
Avery Landing CAP 011.JPG
09/27/2000

Viewing upriver over eastern third of remediated stream bank. Photo shows smaller rock being overlayed by larger

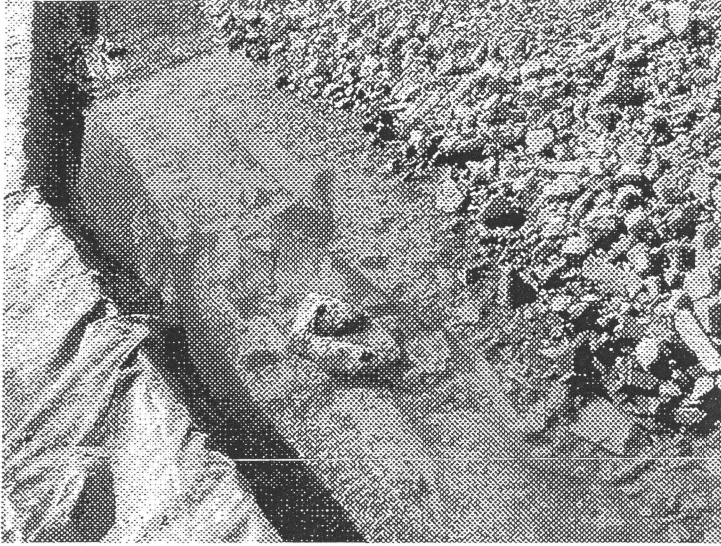
Avery Landing CAP_012.JPG
09/27/2000
Photo of top layer of geofabric at toe of bank

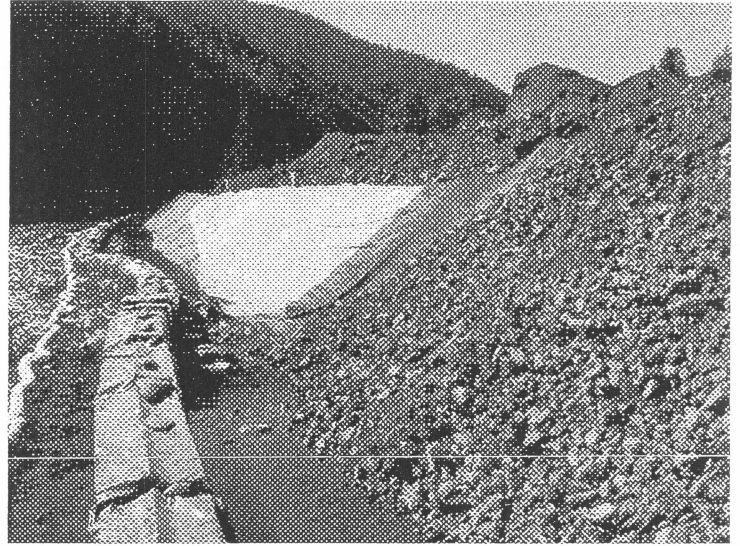
Avery Landing CAP_013.JPG
09/27/2000
Viewing downstream thru center portion of site. Photo shows the geofabric, liner, and rock cover

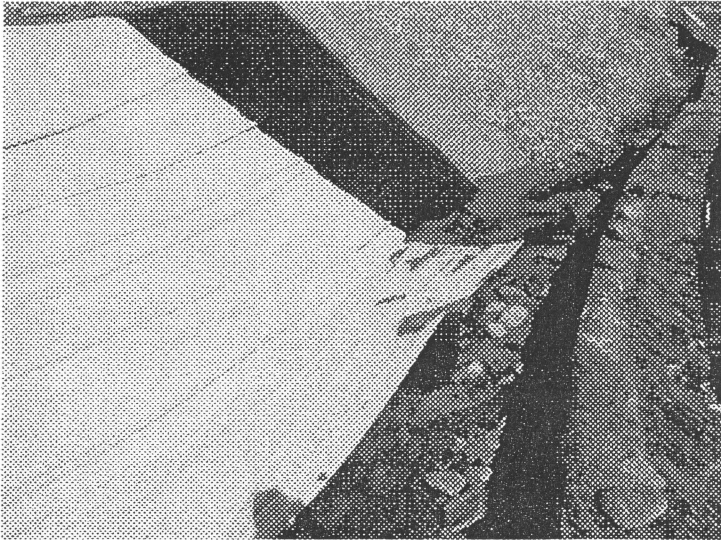
Avery Landing CAP_014.JPG
09/27/2000
Upstream view of same area as previous photo

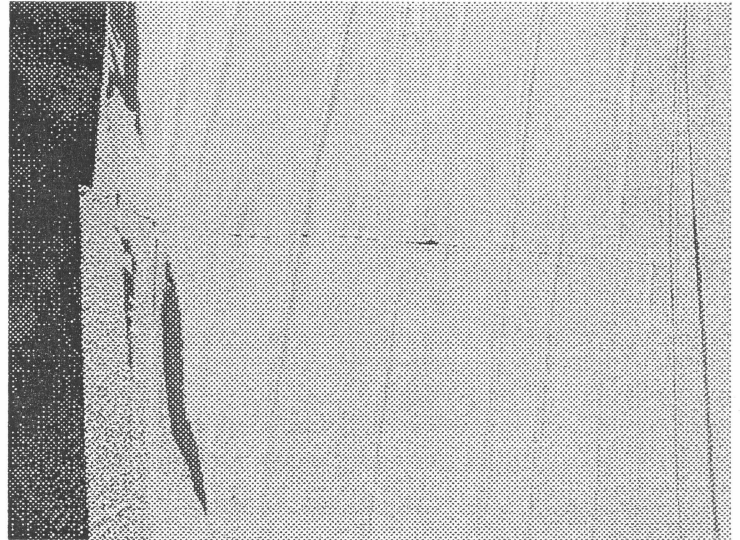
Avery Landing CAP_015.JPG
09/27/2000
Photo of a manufactured seam in the liner

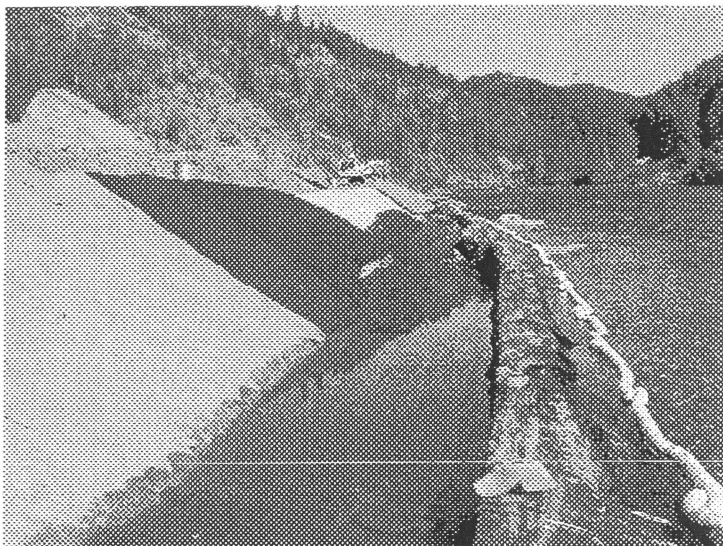
Avery Landing CAP 016.JPG
09/27/2000
Viewing upstream over eastern half of site

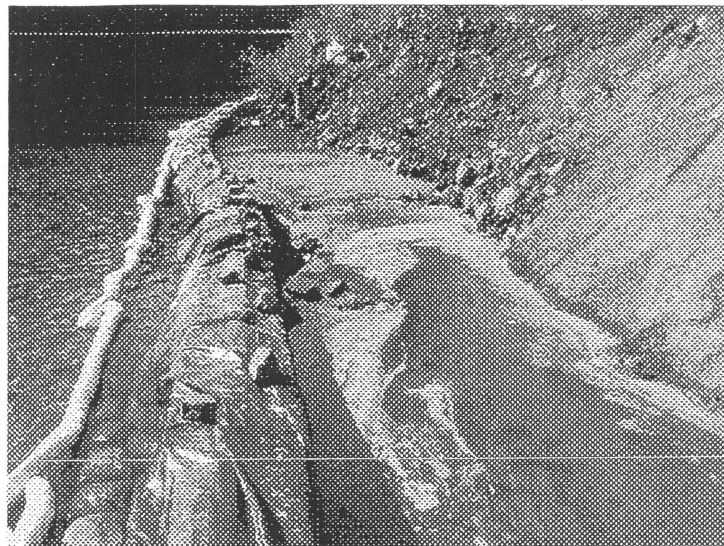
Avery Landing CAP 017.JPG
09/27/2000
Photo of petroleum scum buildup on extreme W end of site

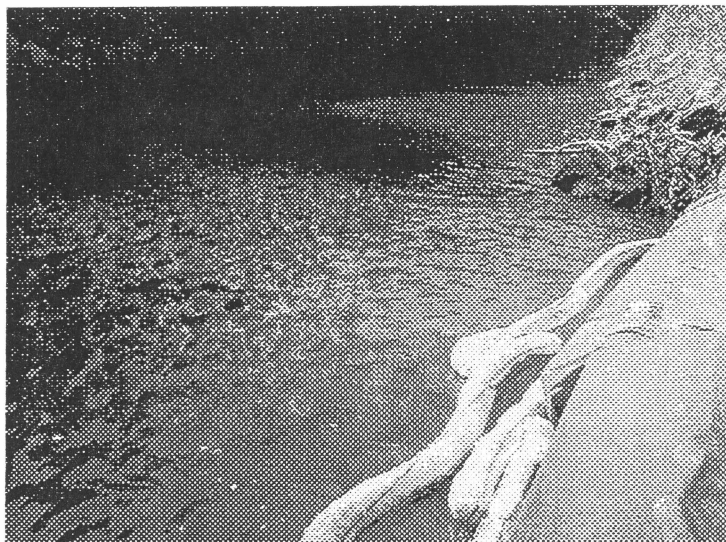
Avery Landing CAP 018.JPG
09/27/2000
Photo of river side of coffer dam at W end of site. Some silt but no petroleum was escaping past the dam

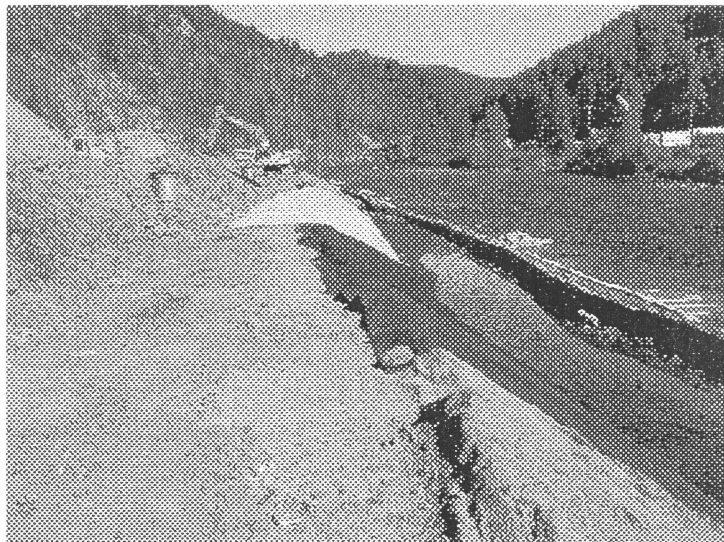
Avery Landing CAP 019.JPG
09/27/2000
Photo showing how geofabric is draped over top of slope

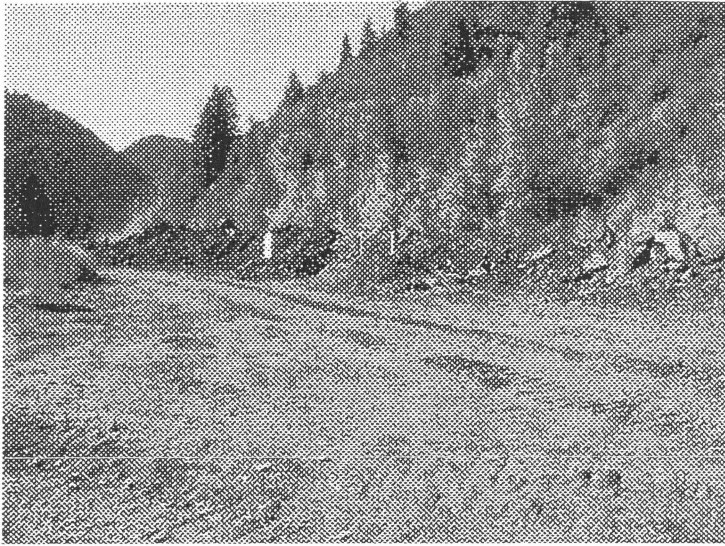
Avery Landing CAP 020.JPG
09/27/2000

Viewing E over a pile of rock and soil that was excavated and stockpiled along the hwy

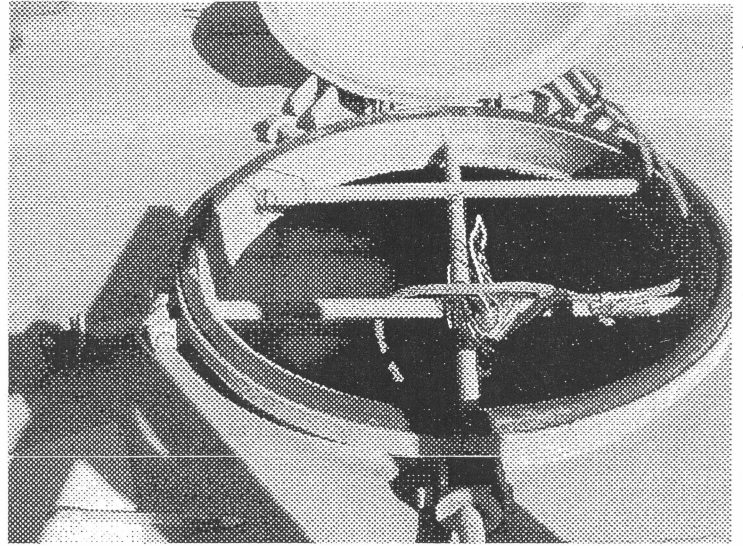
Avery Landing CAP 021.JPG
09/27/2000

Top entrance to O/W separator. Although not evident, tank was nearly full; very little petroleum film on top of water

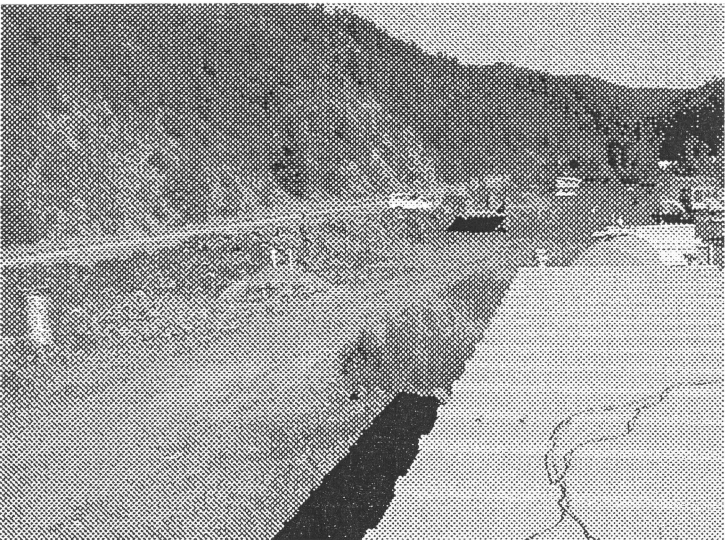
Avery Landing CAP 022.JPG
09/27/2000

Viewing E across stockpiled soils on N end of site

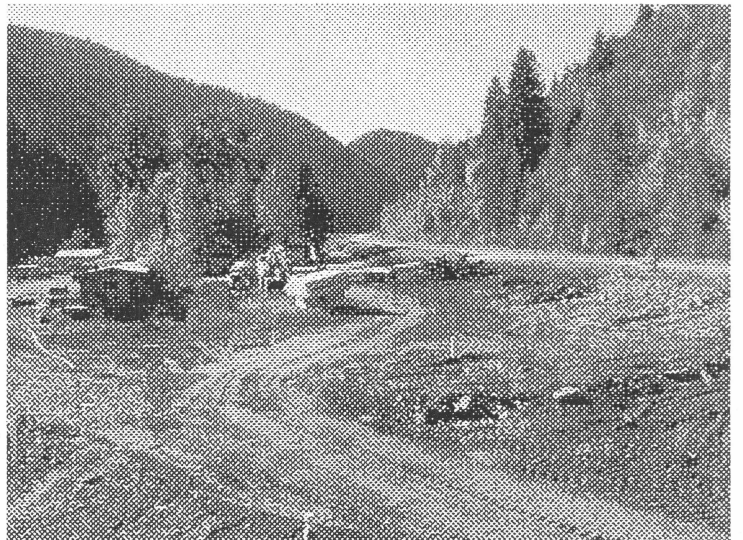
Avery Landing CAP 023.JPG
09/27/2000

Viewing W across W end of site. Crew working on liner, on hwy, in background

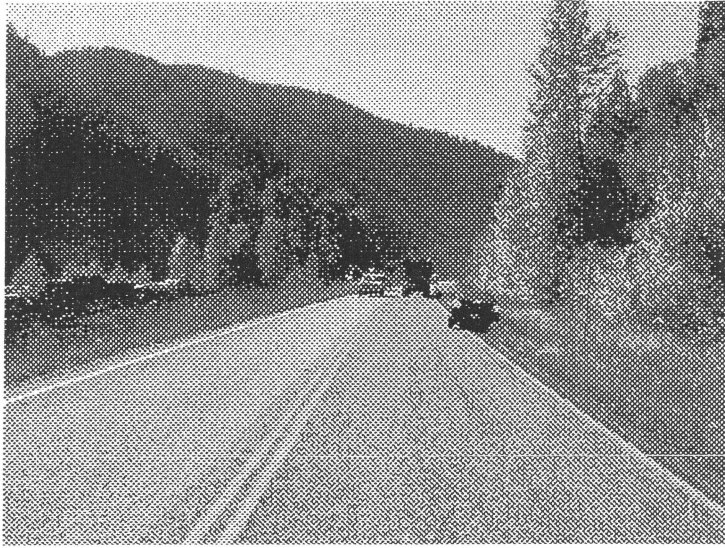
Avery Landing CAP 024.JPG
09/27/2000

Photo of re-rolled liner being brought back to site

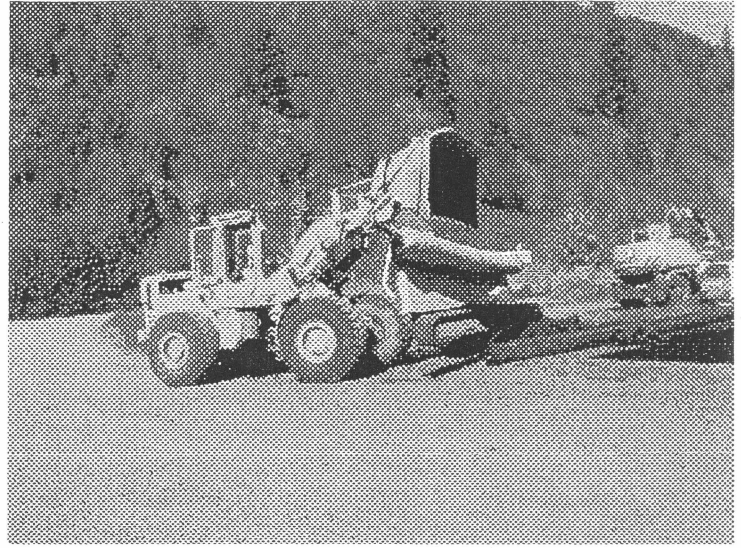
Avery Landing CAP 025.JPG
09/27/2000

Photo showing how liner has been rolled onto long bar then is suspended to be pulled out along the bank

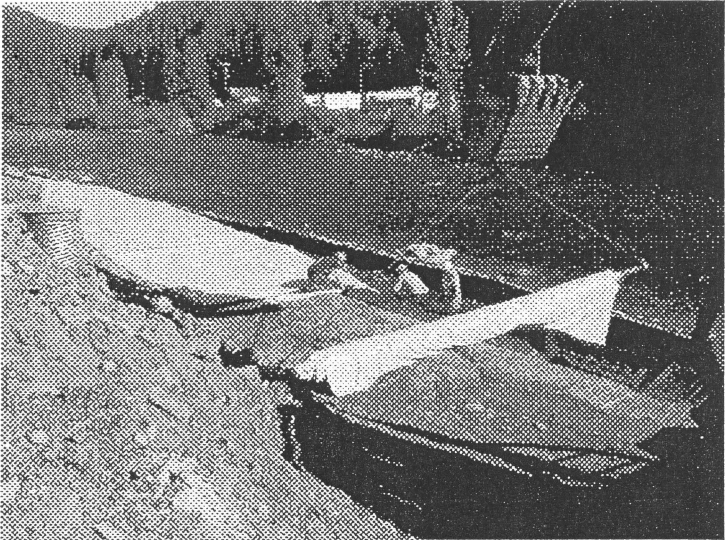
Avery Landing CAP 026.JPG
09/27/2000

Photo showing roll of liner positioned over band. Rock "barb" in background

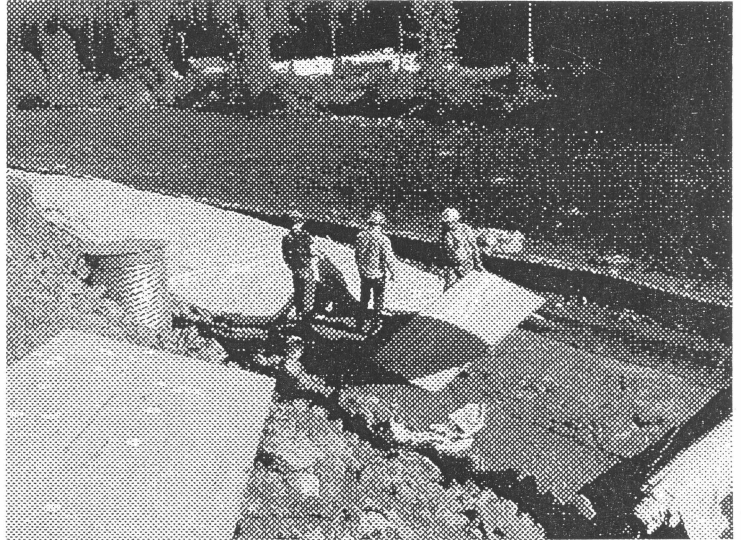
Avery Landing CAP 027.JPG
09/27/2000

Workers preparing to splice the 2, 400' rolls of liner. Wooden platform in bg shows how low river is

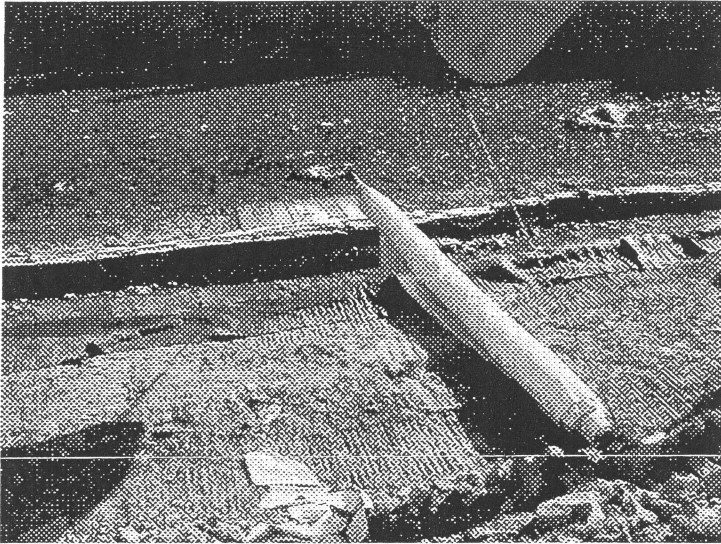
Avery Landing CAP 028.JPG
09/27/2000
Same as previous photo

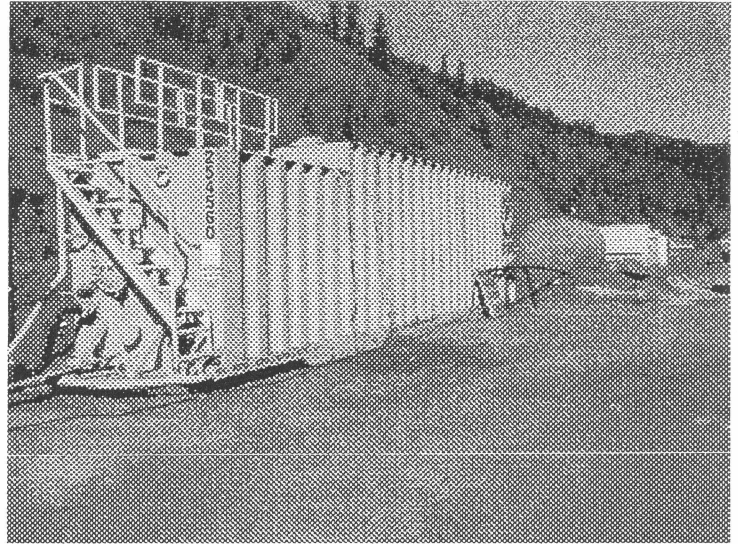
Avery Landing CAP 029.JPG
09/27/2000
O/W separator "overtopping". Workers turned on river pump but didn't turn on pump that delivers water to infil. tre
